ROV, Remote Operated Vehicle

Surveys, identification, inspection, sampling, recovery, filming Perfect to investigate Sidescan findings

Specifikation ROV

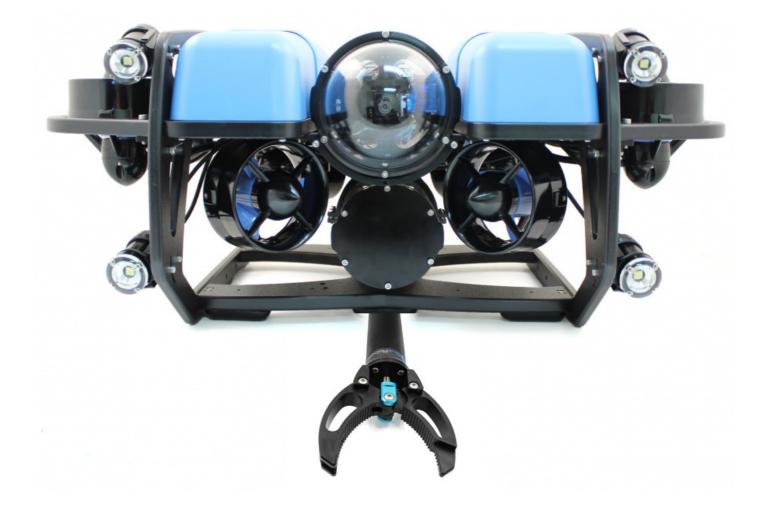
Max workdepth 400 meters Camera Full HD 1080x1920 with recording Manipulator/gripper Instruments: Scanning Sonar, INS, Accelerometers, Depthmeter, tempmeter

Underwater positioning, SBL system to position the ROV within 1 meter: Get position of ROV, Move ROV to position, move ship after ROV

Vectorized power; moves all directions. Usage: Currents, rotation around object Thruster power 14 kg, Speed over 2 knots Weight 11 kg, Length 500mm Lights 2 x 1 500 lumens, with dimmer Control modes: manual, heading, depth, stabilized Electric power: 240 V AC from surface, or LiPo acc onboard

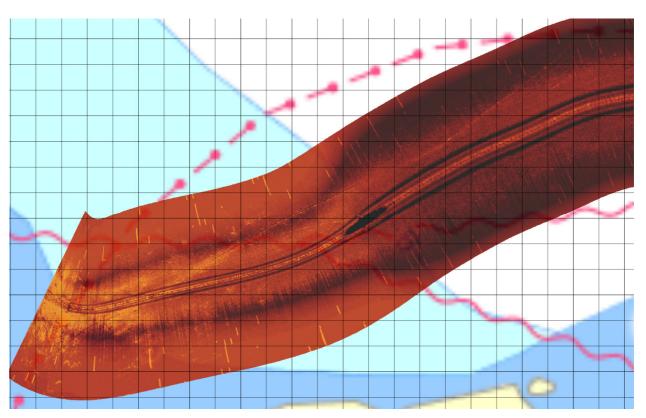
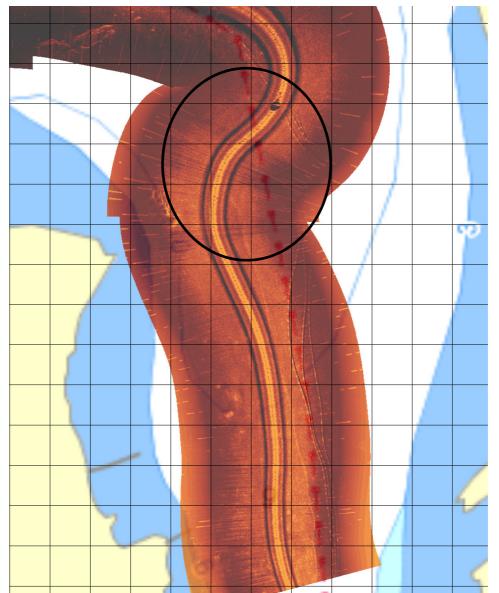
How Sidescan from seabed can look

Pipes is not accurate on navchart:

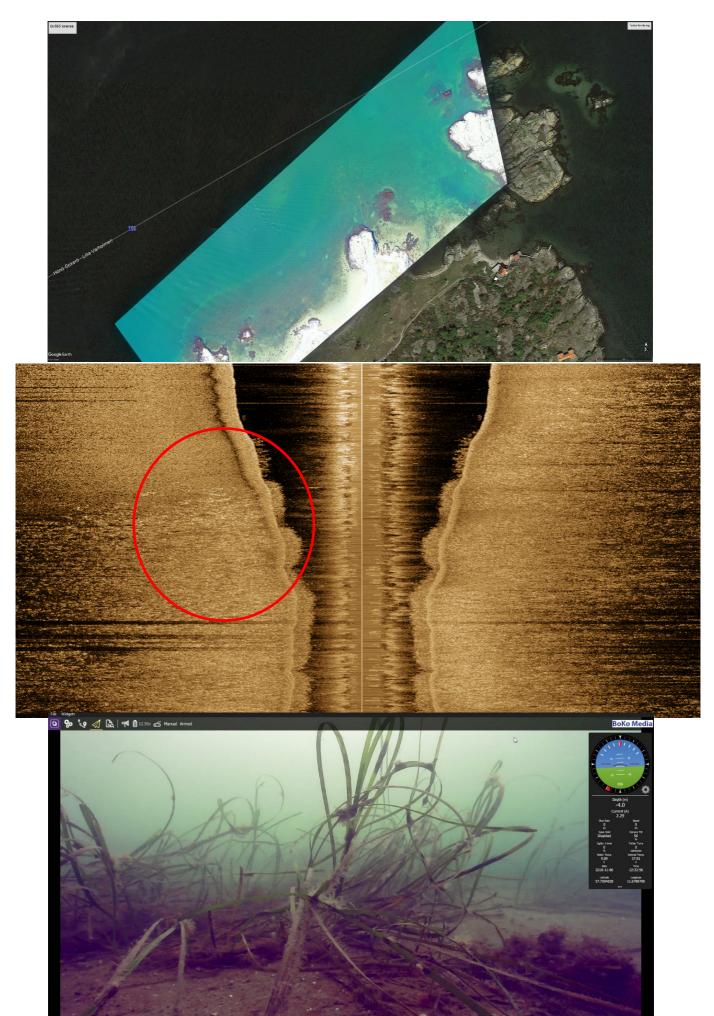
Quick Eeelgrass survey with Air Drone and ROV

Check with Sidescan, Eelgrass ends where seabed deepens Verifying with ROV

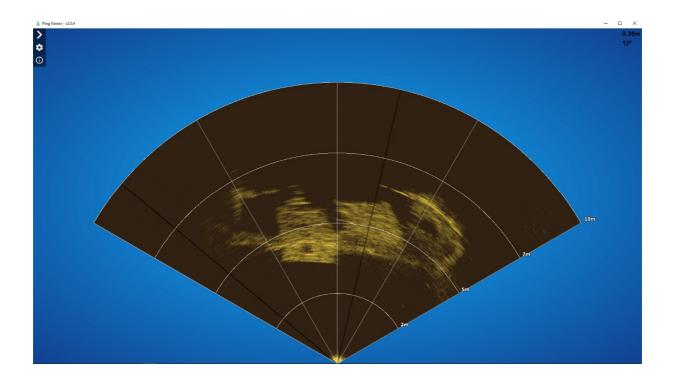
Navigating to object with ROV In bad visibility sonar is a good help to navigate In this case to an 8 meter wreck

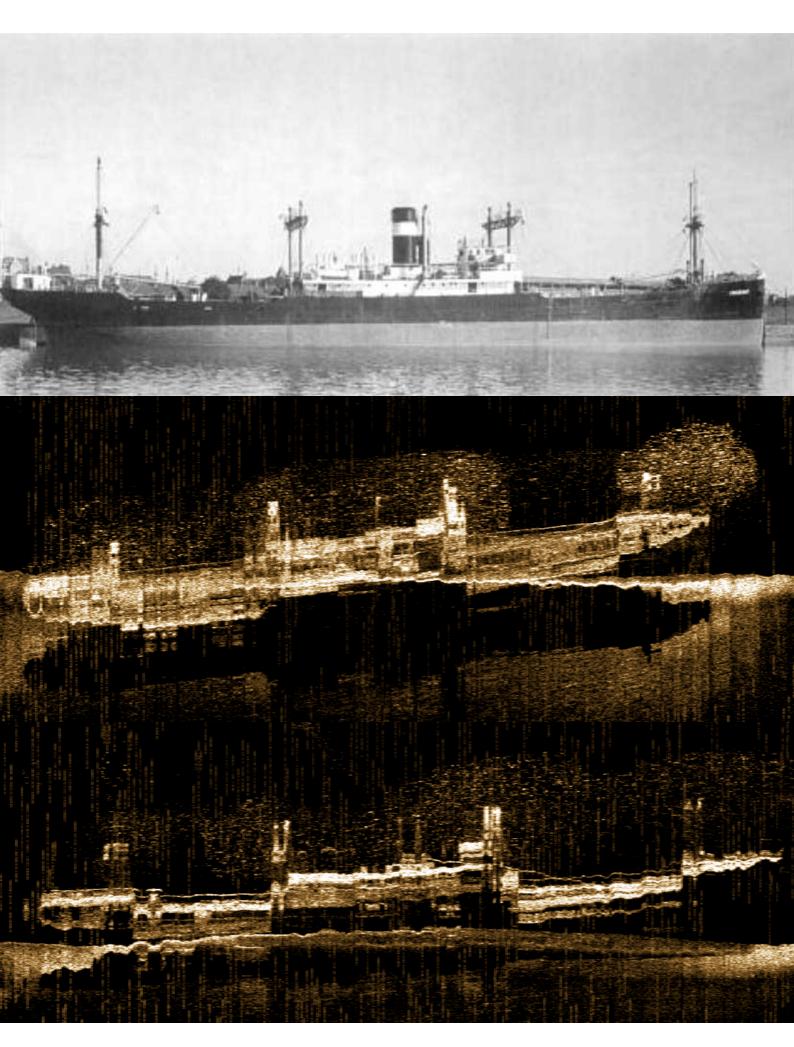
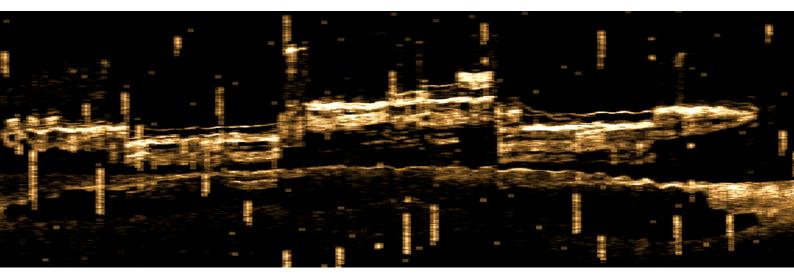
Picture page above from towfish Sidescan Picture below hullmounted Lowrance LSS-2 swinger

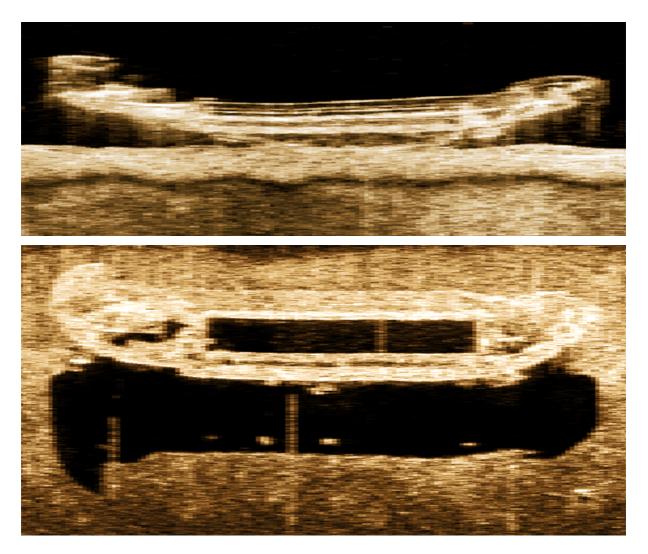
Wreck Ardennia outside Ussholmen, Marstrand, depth 14 meters Sank 1934, later scrapped for metal reuse

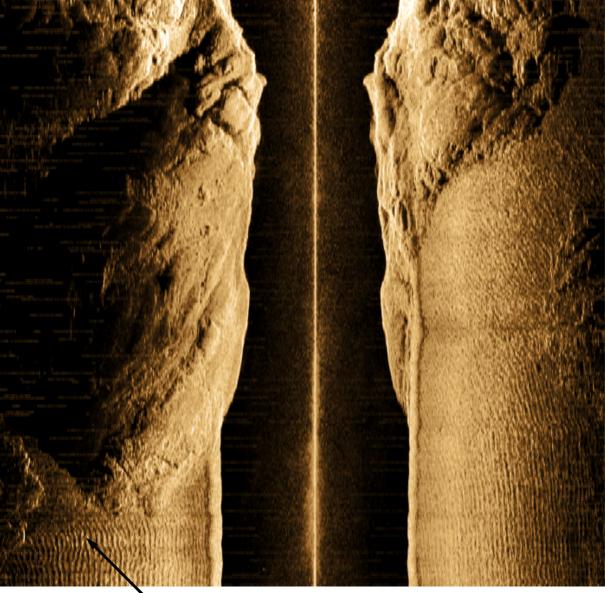
Rock ridges with sand between

Wave pattern in the sand
